# A-6 Intruder

# WALK AROUND

**By Lou Drendel**

**Walk Around Number 2  
squadron/signal publications**

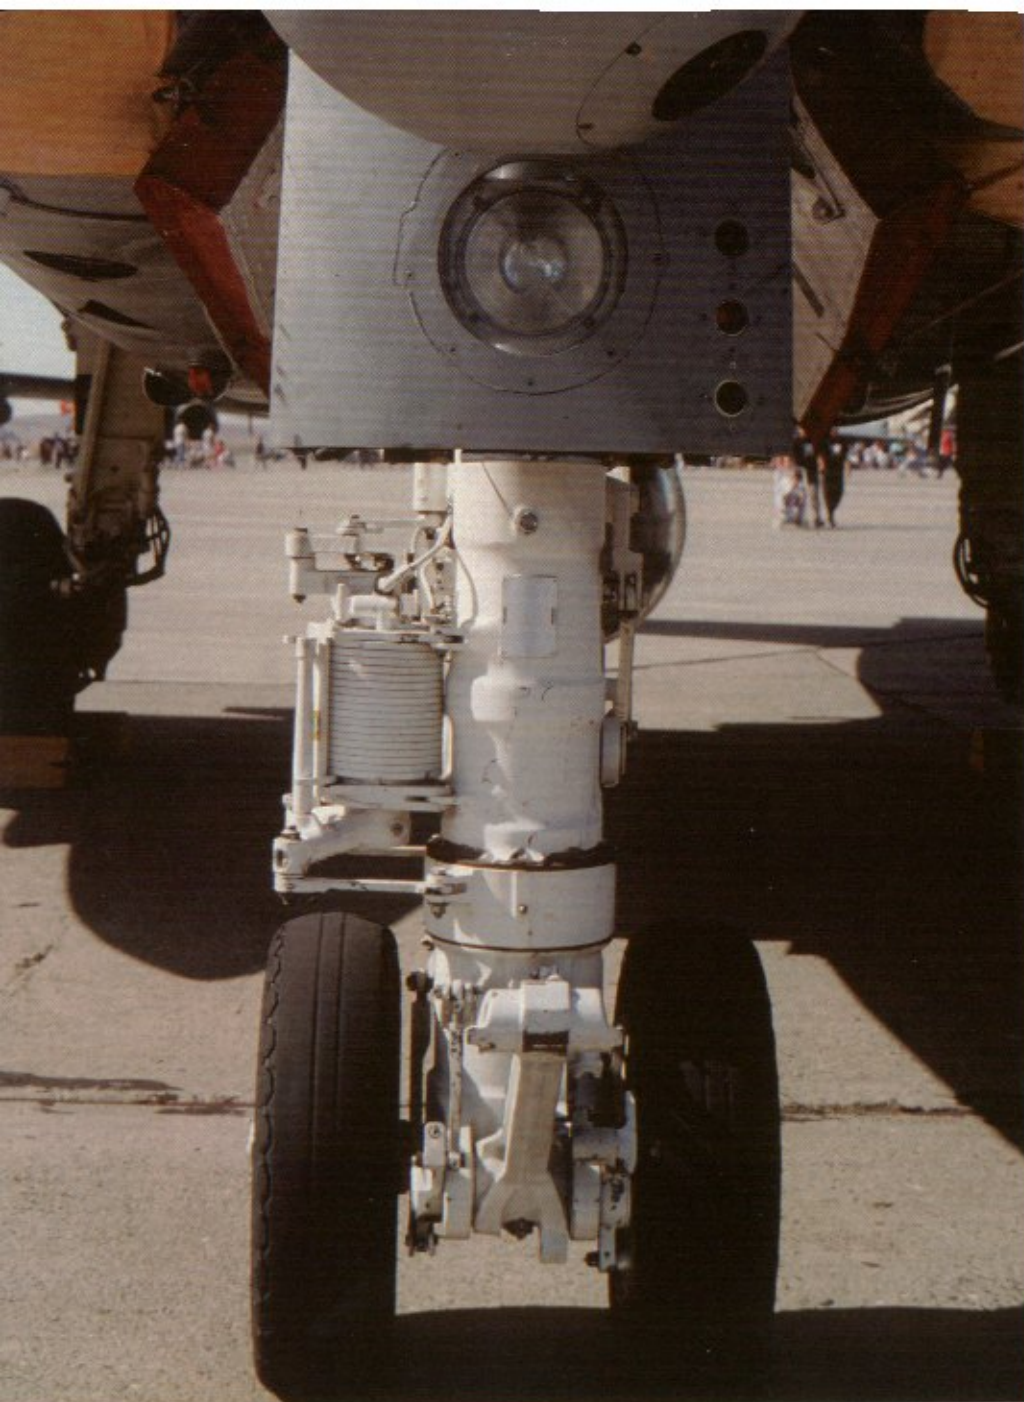
The nose landing gear strut has the catapult tow bar attached to the front. The large circular object attached to the right side of the strut is the hydraulic nose wheel steering mechanism.

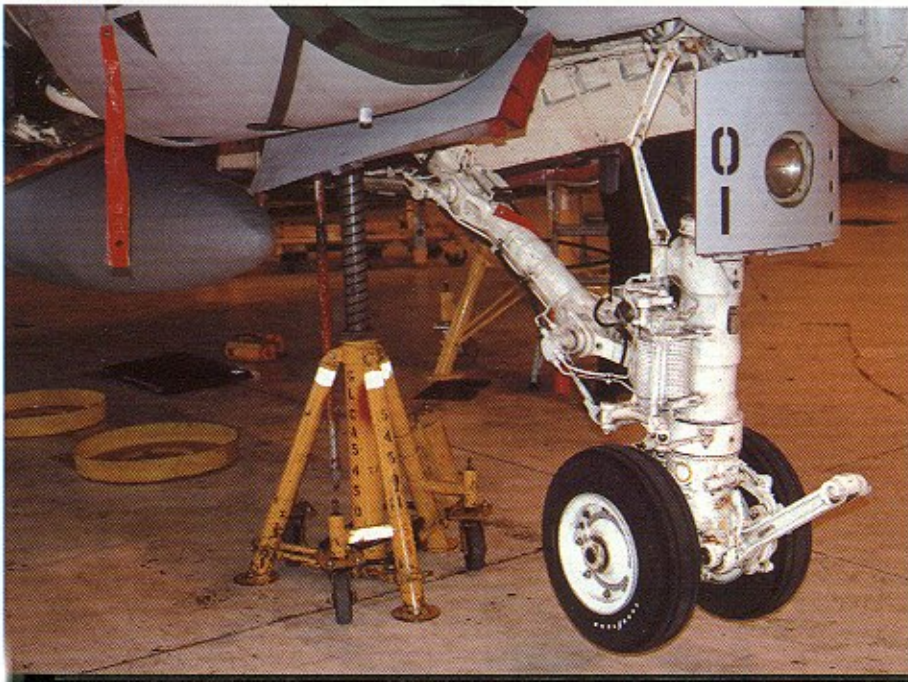
This A-6E is hoisted on jacks for landing gear maintenance. The stabilizing oleo scissors link is fully extended. The Black lines running down the retraction strut are nose wheel steering hydraulic lines.

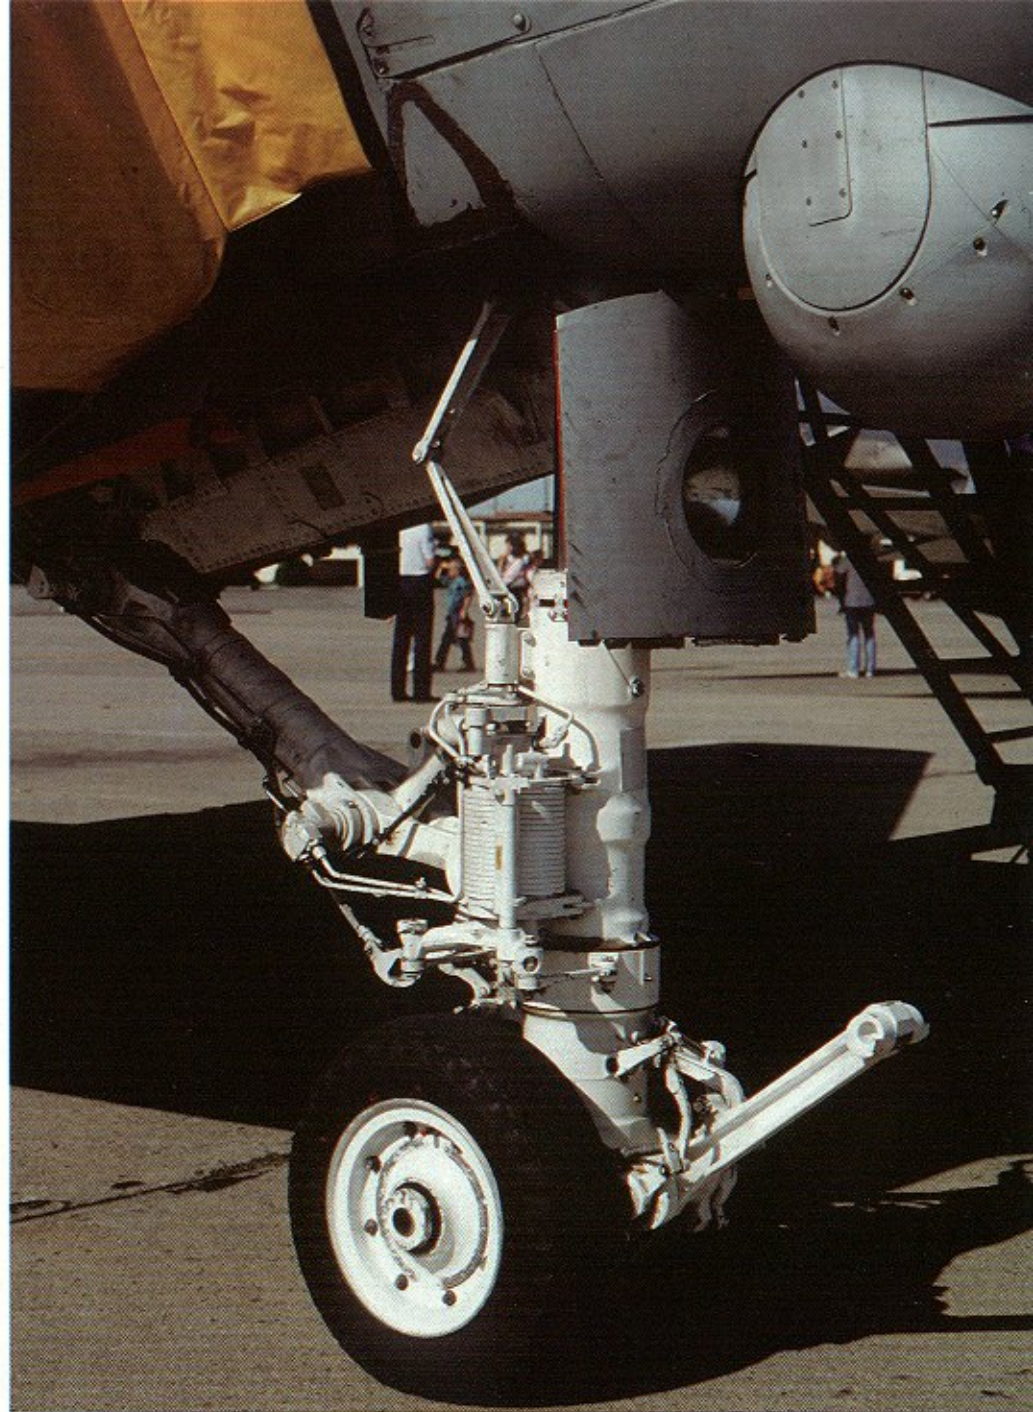
The catapult tow bar is in the raised position. When the aircraft is positioned on the catapult the bar drops down and engages the catapult shuttle. Once the aircraft is released from the catapult, the bar returns to the raised position.

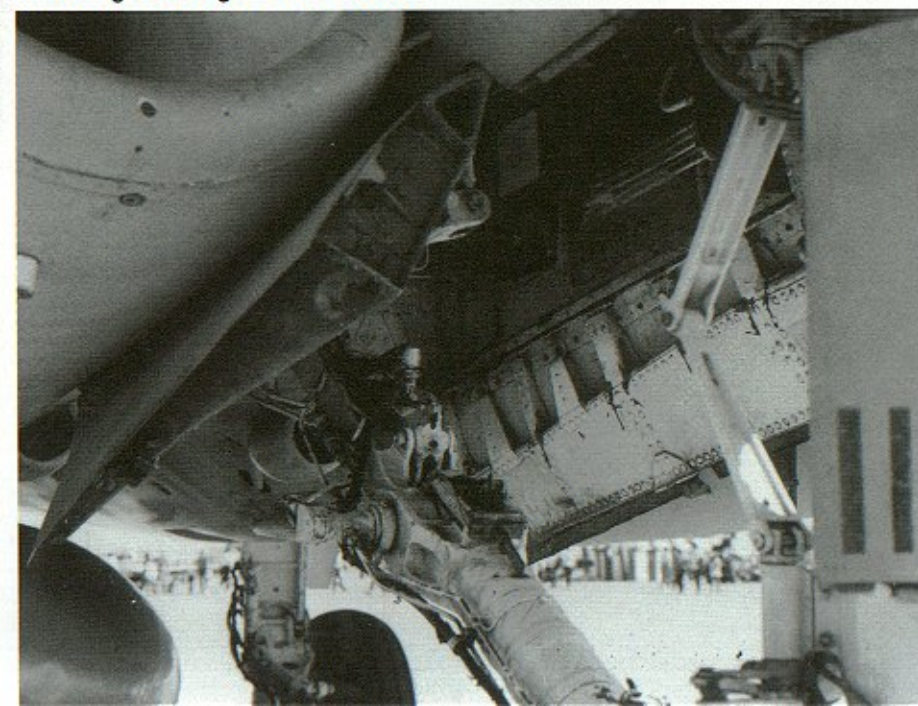
There are only very slight differences between the nose landing gear of the A-6A through A-6E variants and the nose landing gear of this EA-6B Prowler.

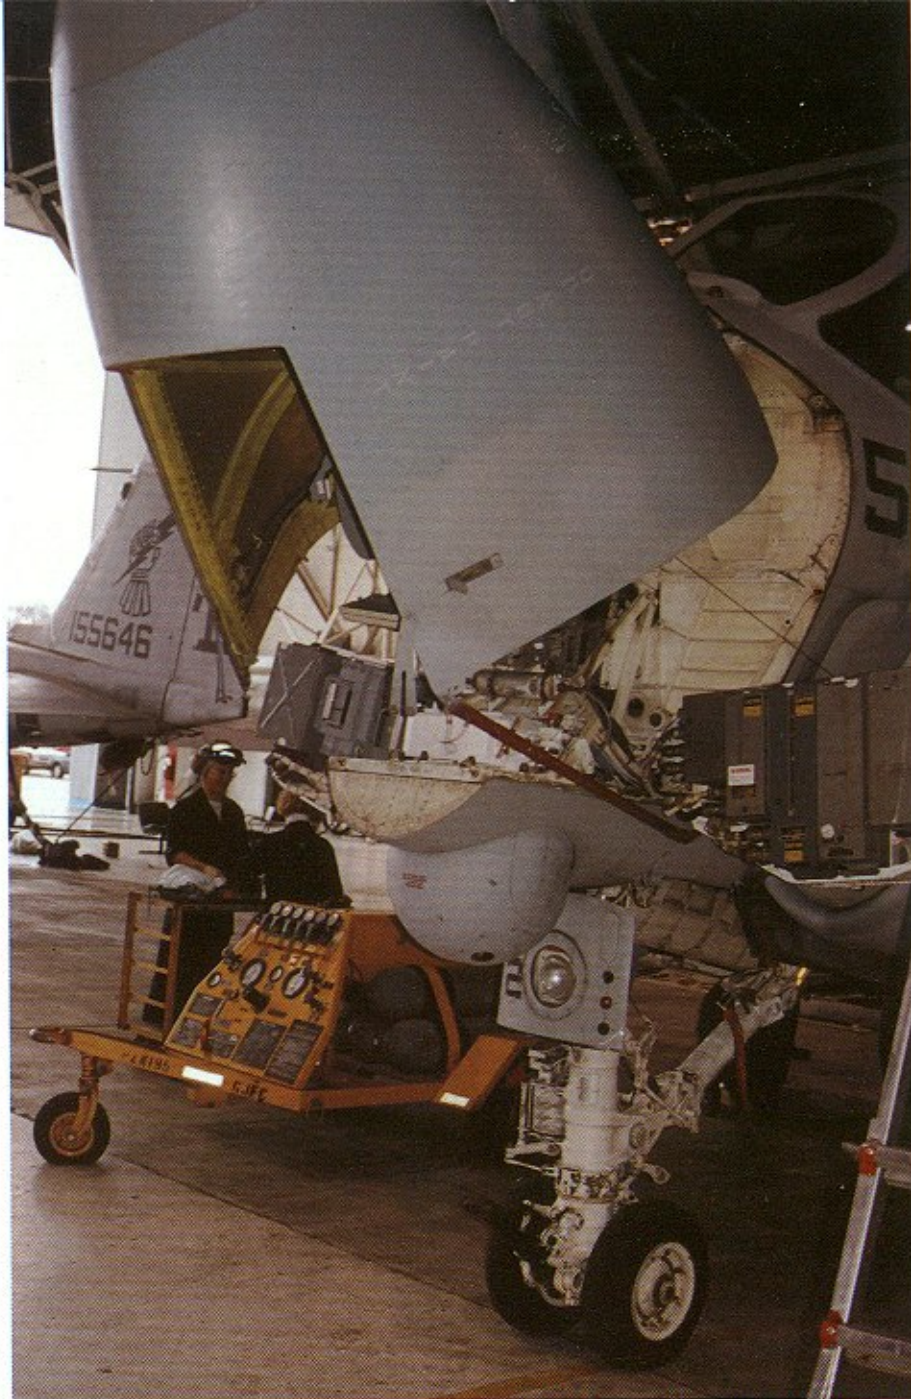
The radome has been swung open on this A-6E TRAM for servicing of the AN/APQ-156 multi-mode radar. The interior of the radar bay is white, while most of the "black boxes" are in fact, Gray.

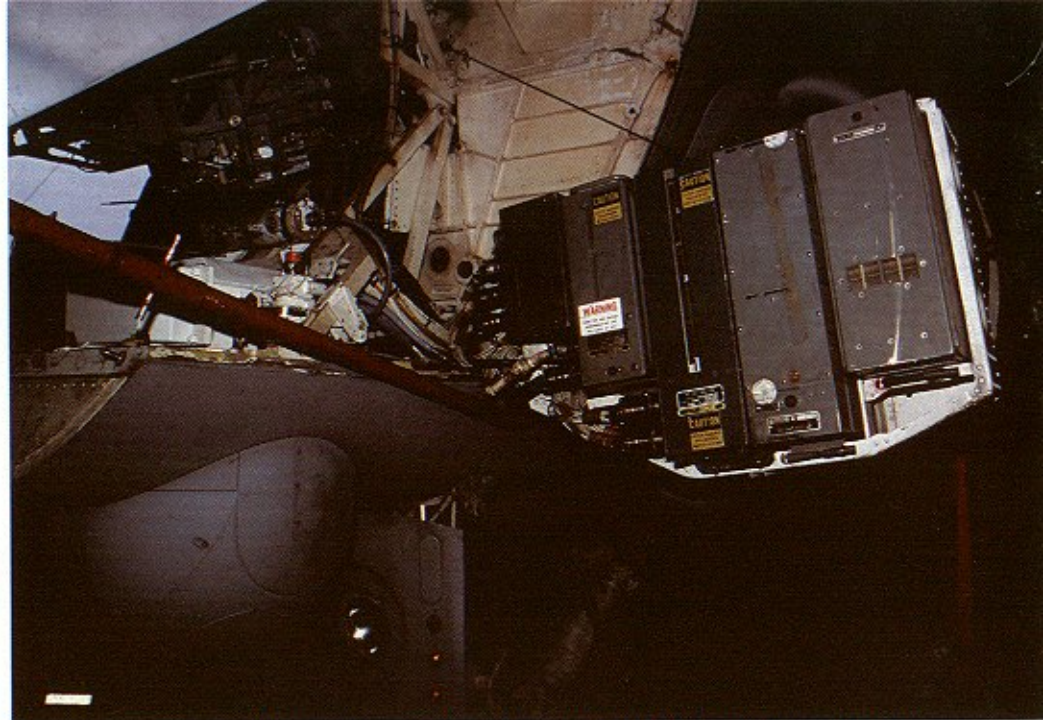
The avionics equipment trays swing out to allow easy access to black boxes on both sides of the radome.

This is the same avionics equipment tray as above, but viewed from the rear.

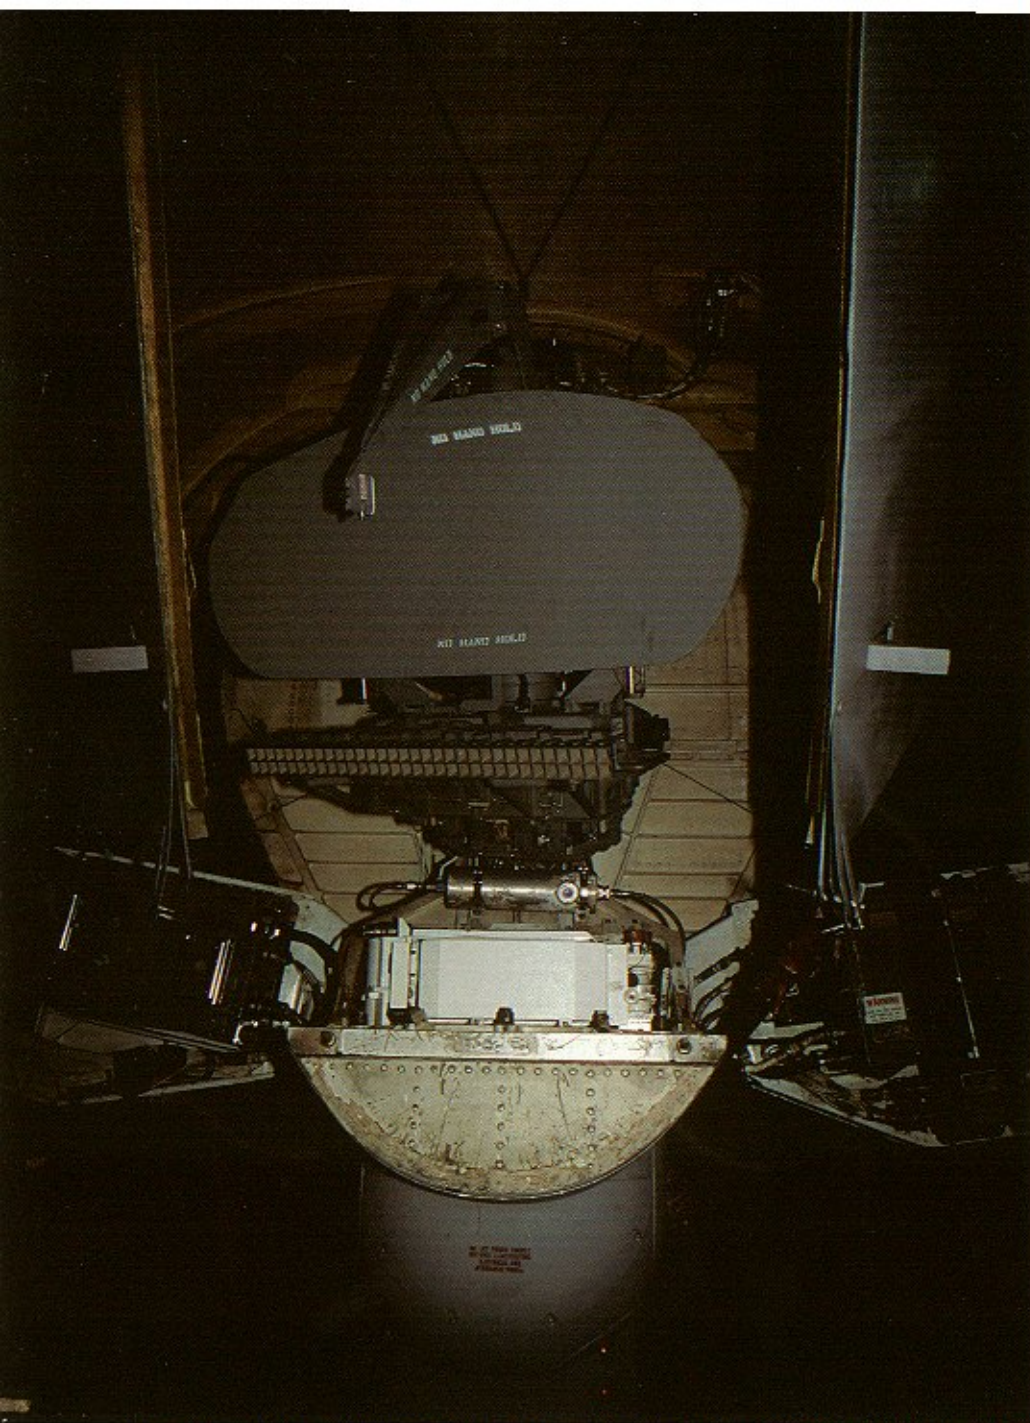
The open radome reveals the large multi-mode radar scanner and smaller intermediate frequency receiver (long "egg crate") under the scanner.

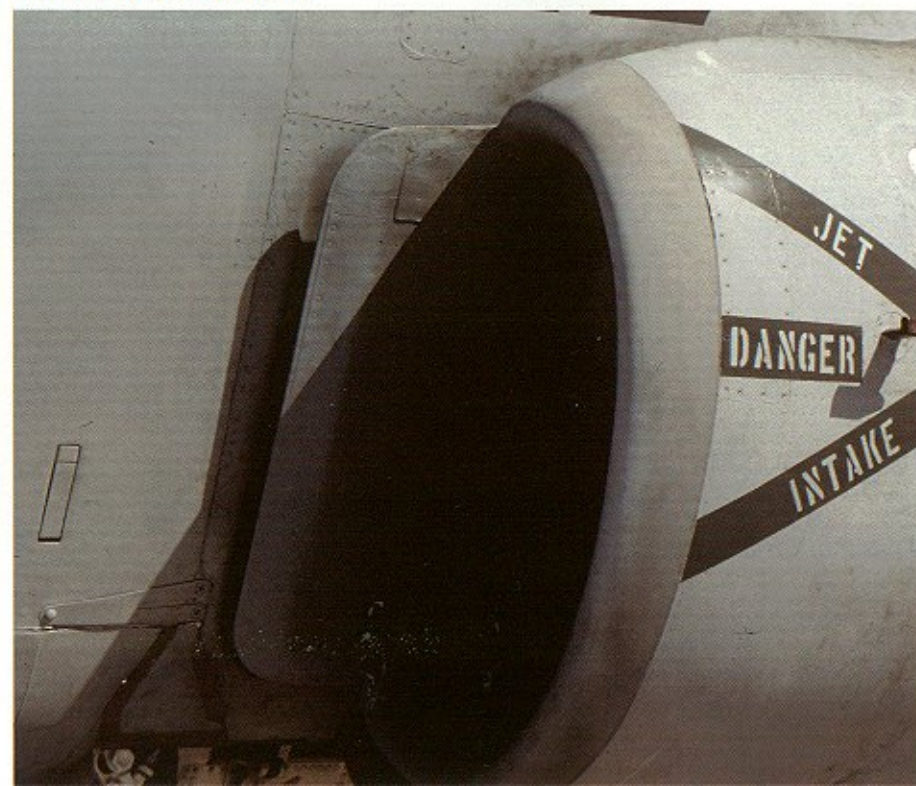
Port engine air intake on an A-6E. The rectangular plate in front of the intake is the boundary layer splitter plate.

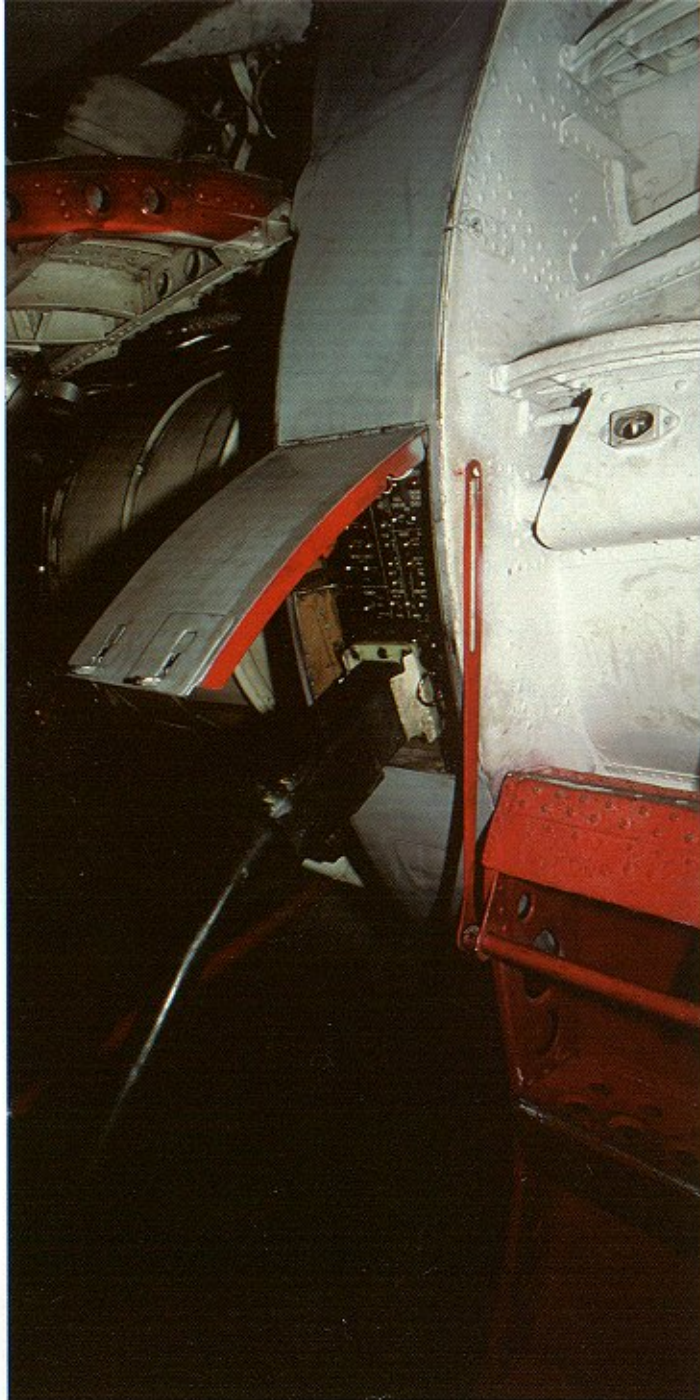
The external power receptacle is on the starboard side of the A-6, just behind the crew boarding ladder.

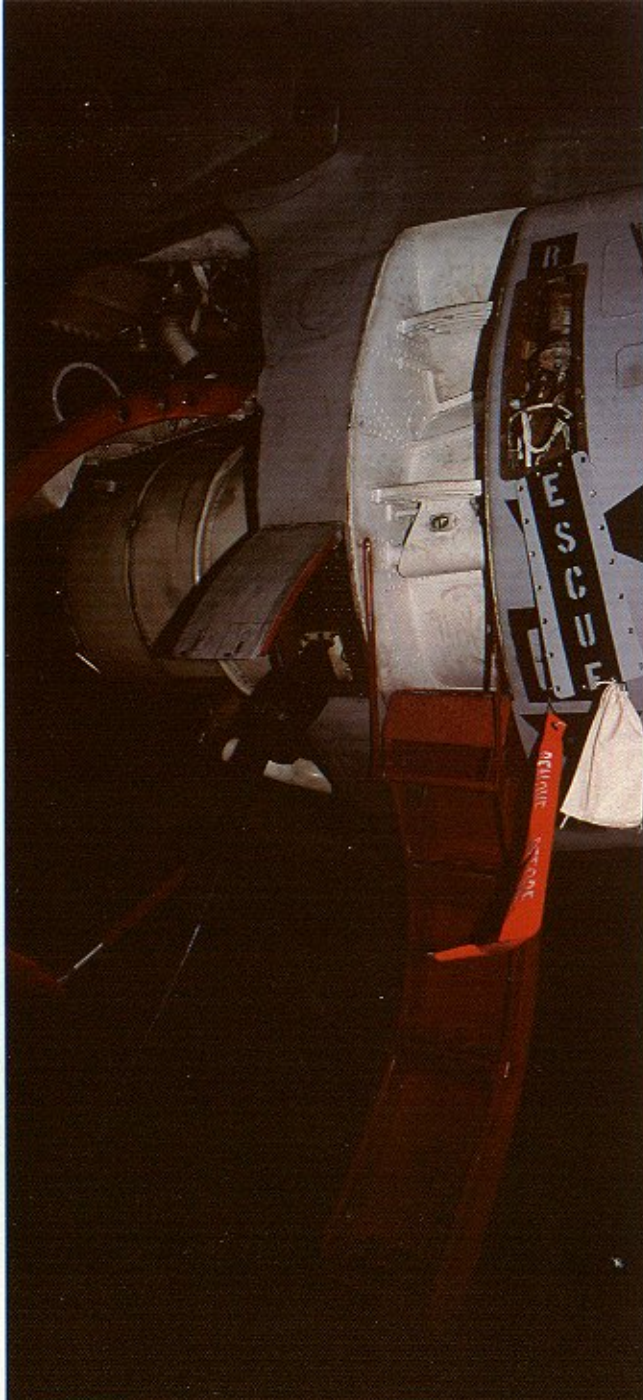
The canopy actuating mechanism is located behind the open access panel to the right of the crew boarding ladder compartment.

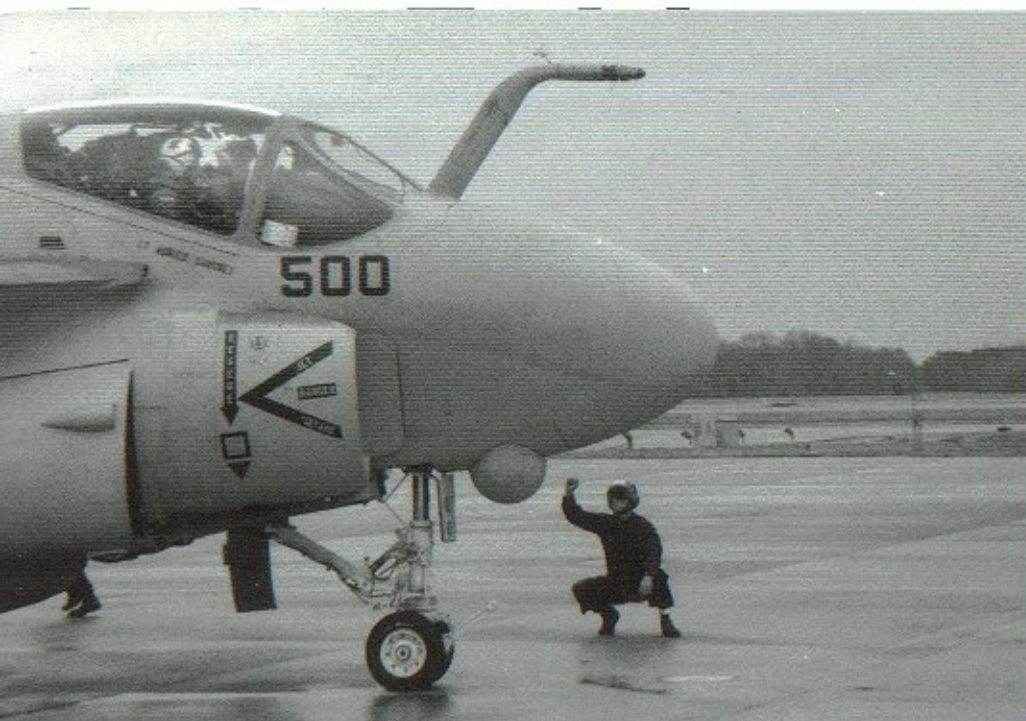
Part of the pre-flight check is the cycling of all control surfaces and nose gear extension/depression. Signals for all movements are given to the pilot by the Plane Captain, who monitors all movements and indicates with a "thumbs up" signal when all are operating properly.

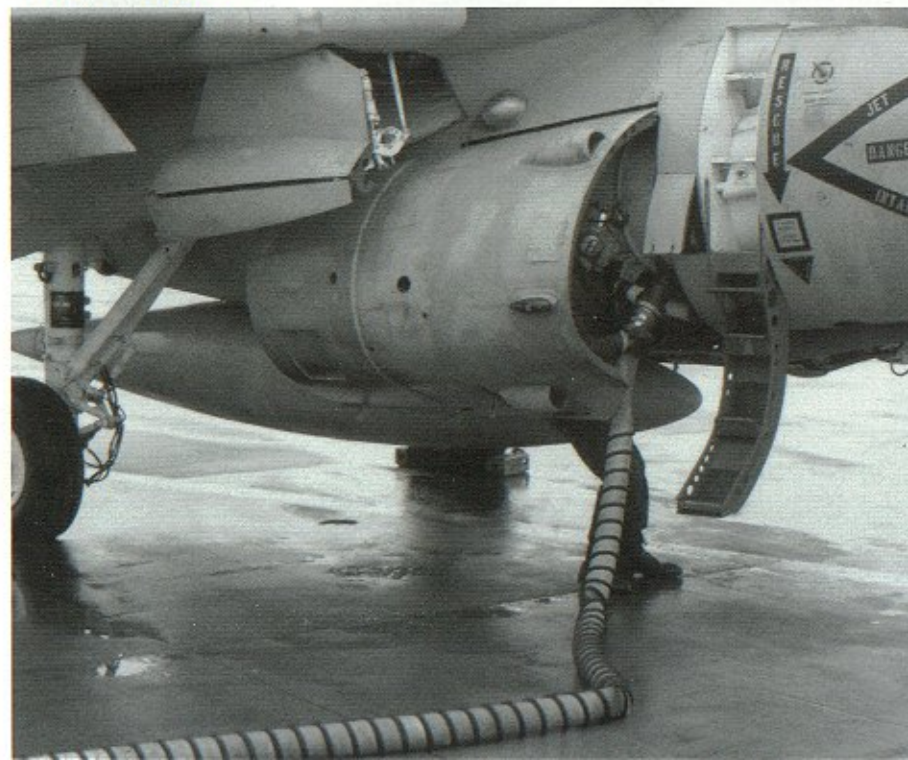
The A-6 has no internal APU or method of self-starting the engines. External air is necessary and it is the responsibility of the Plane Captain to connect the starter cart hose to the engine receptacle.

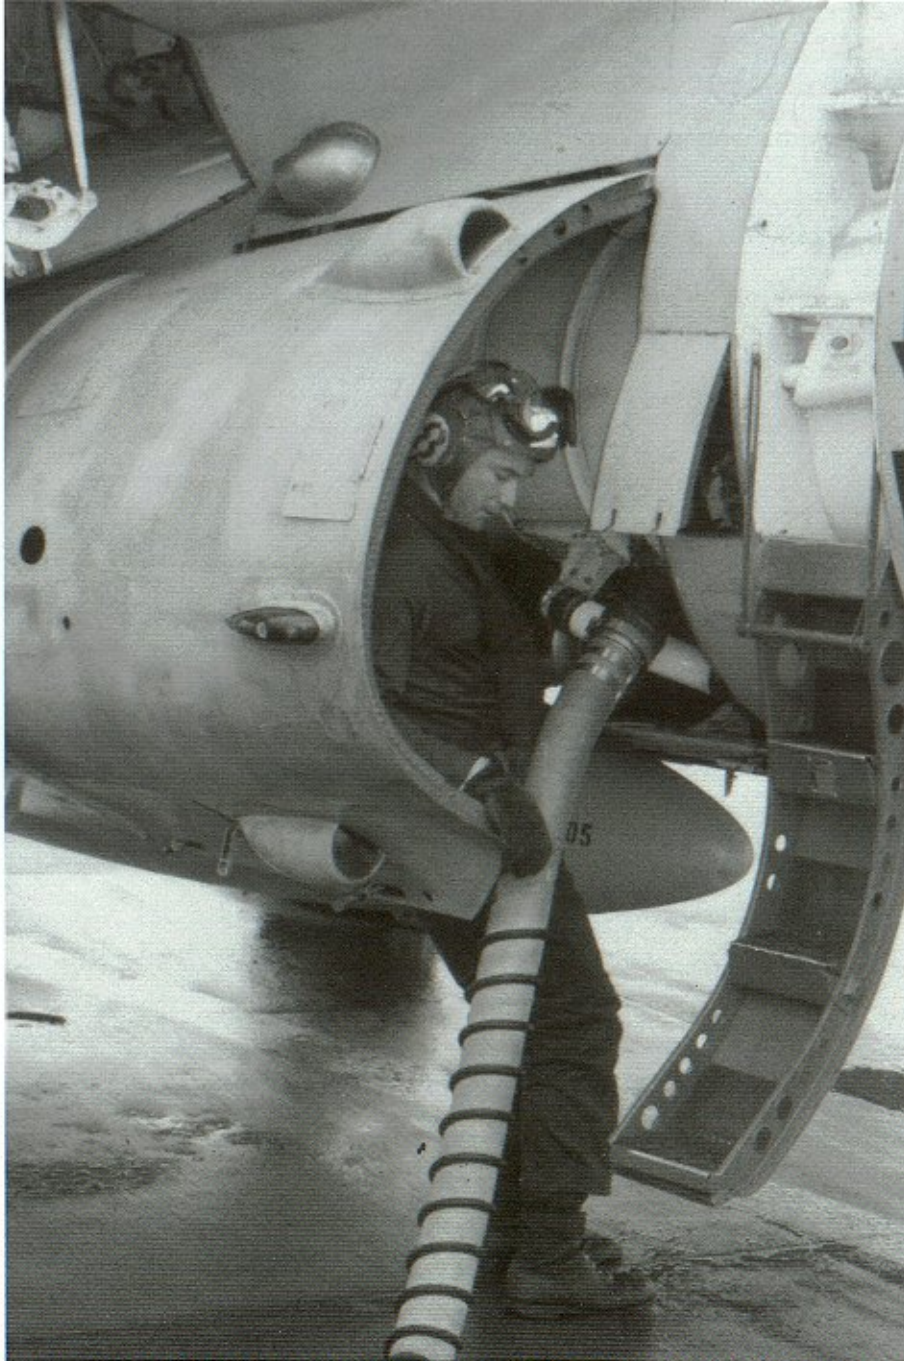
The engines can not be started simultaneously, but either engine can started first. Once the engines are running, one of several ground crewmen who assist in the pre-flight will disconnect the external air hose and secure the access panels on both sides of the fuselage.

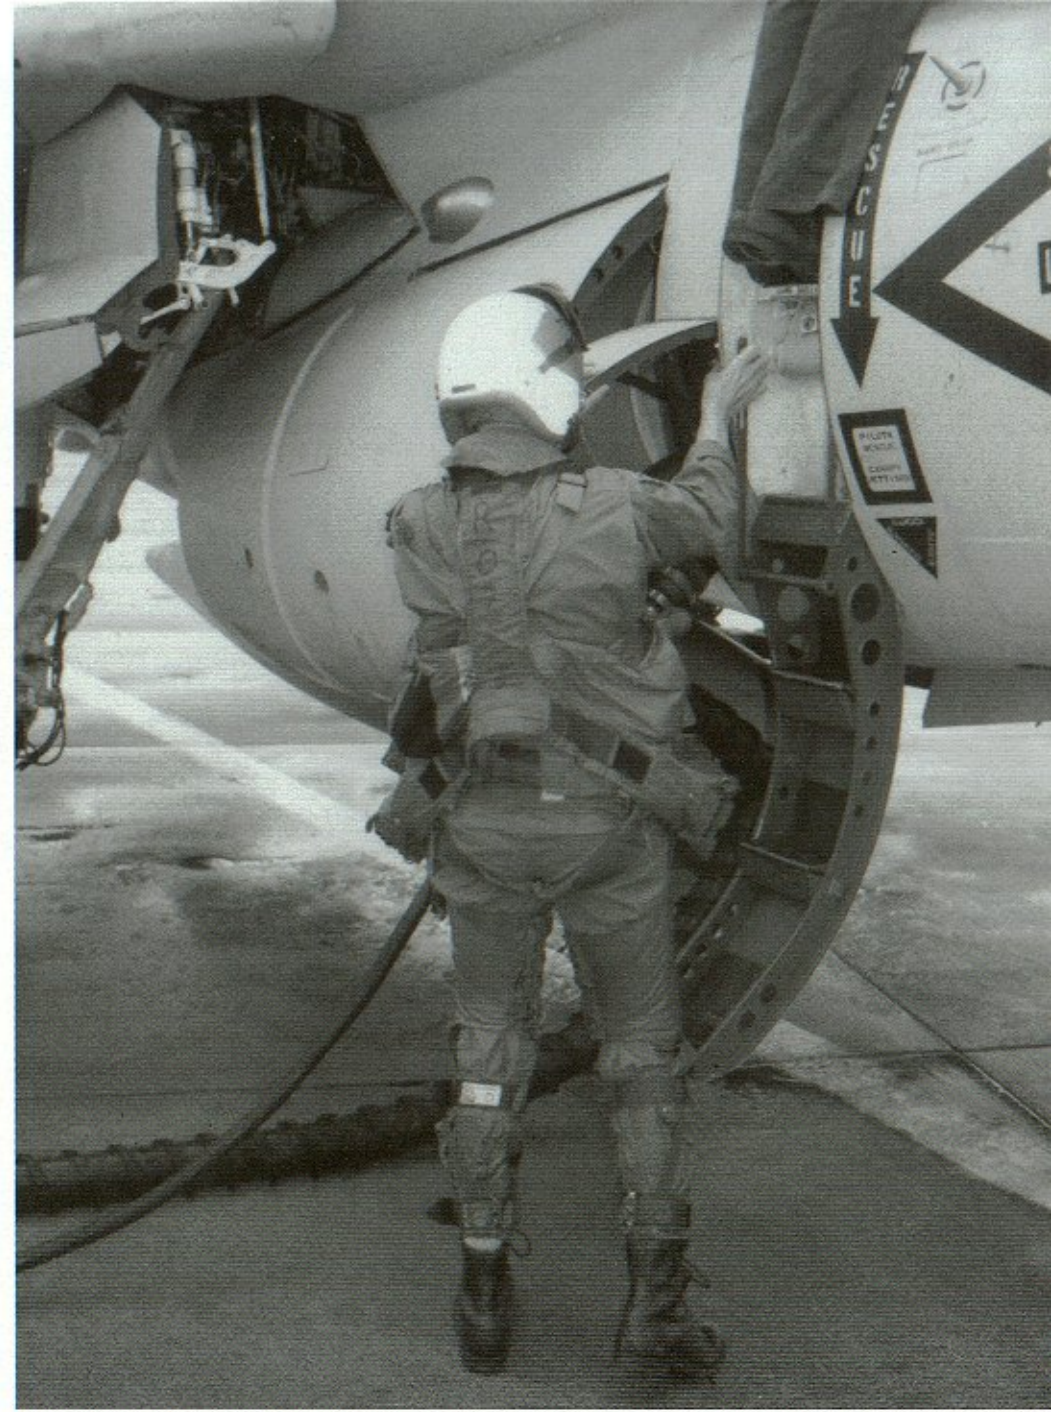
The pilot and/or the Bomb/Navigator (BN) will check the status of the refueling panel switches during their pre-flight walk around.

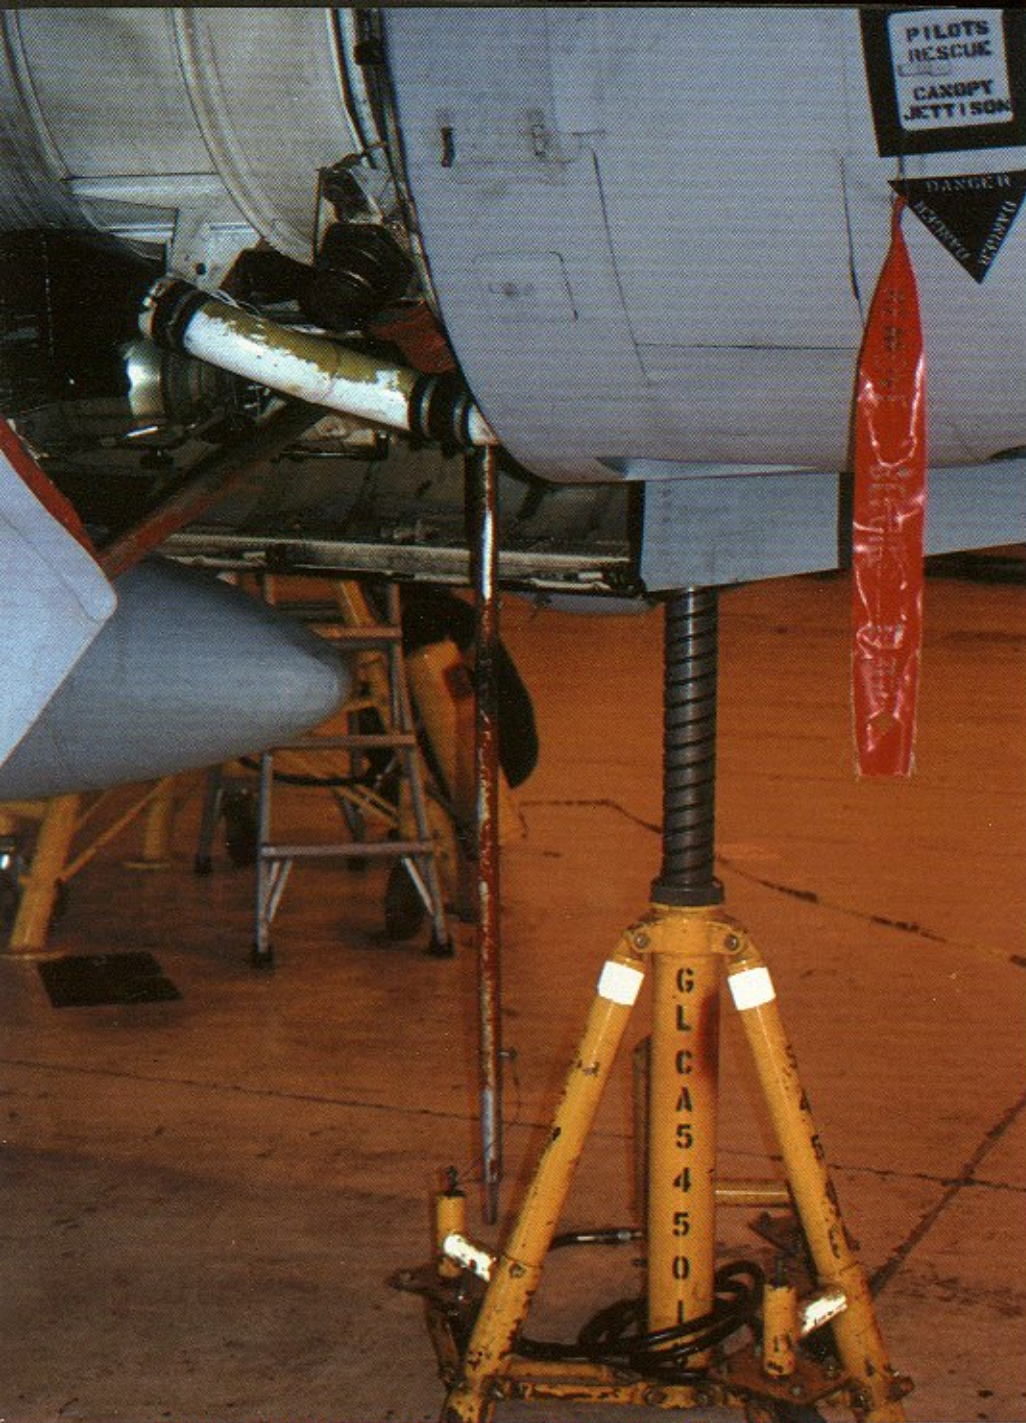
Small hydraulic jacks are used to support the nose of the A-6 when undergoing maintenance to the nose gear and related systems.

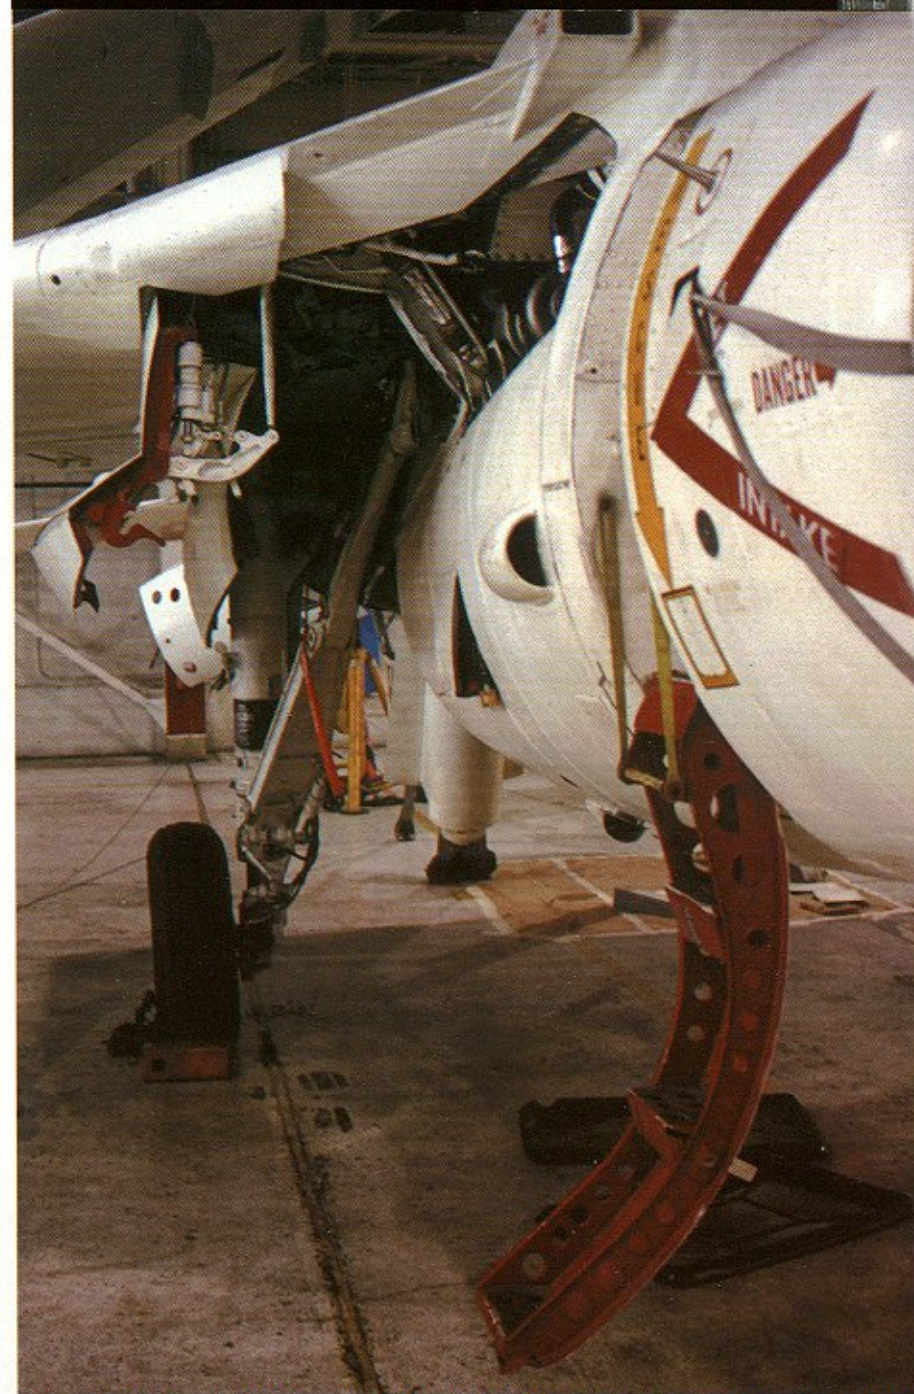
The starboard boarding ladder is used by the Bombardier/Navigator (BN). The underwing panel has been removed to service the aircraft's air conditioning unit. The large air intake at the wing root supplies ambient air for the environmental control unit.

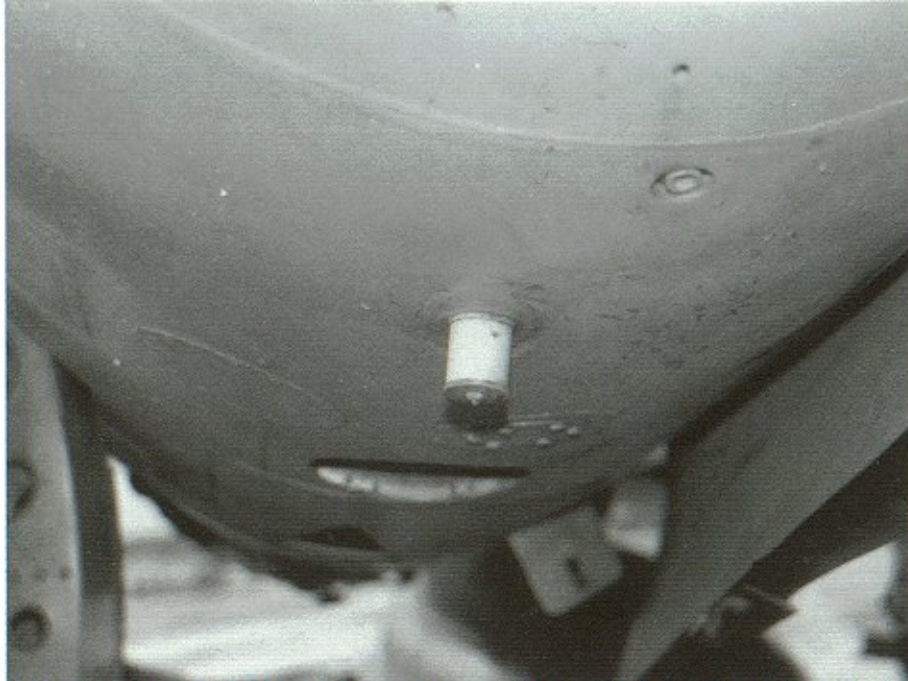
The post antenna for the Automatic Carrier Landing System (ACLS) is located under the nose, just to the rear of the TRAM turret and offset slightly to starboard on the A-6E .

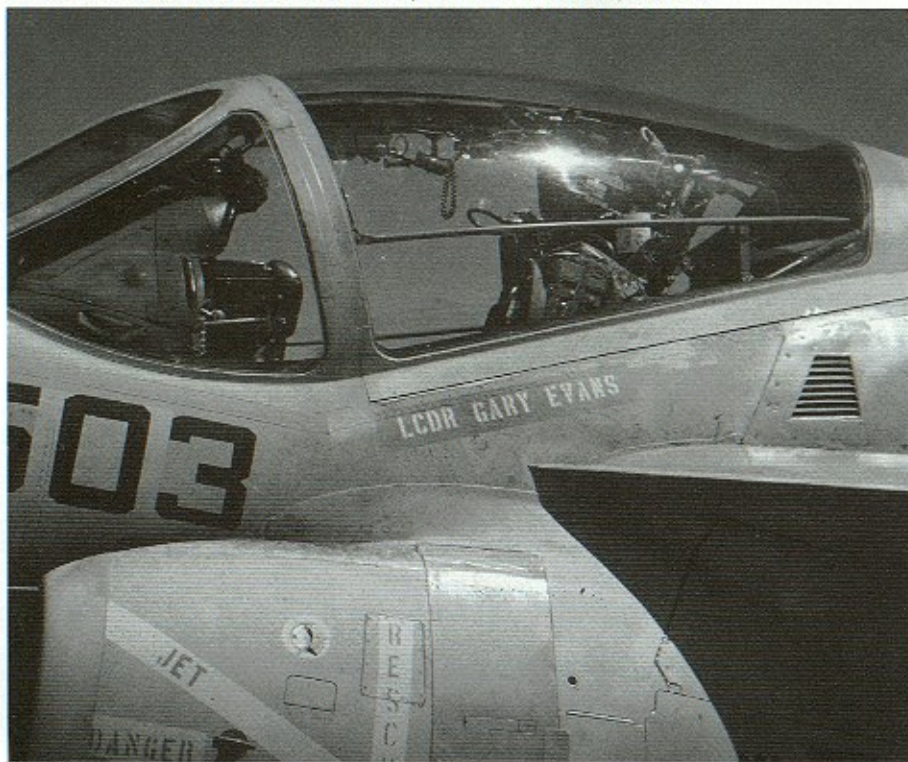
Engine bleed air is used to blast rain and/or ice from the windscreen. It is directed upward from this row of vents mounted at the base of the windscreen. The small fairing just forward of these vents is the refueling light which shines on the refueling probe during night refueling operations.

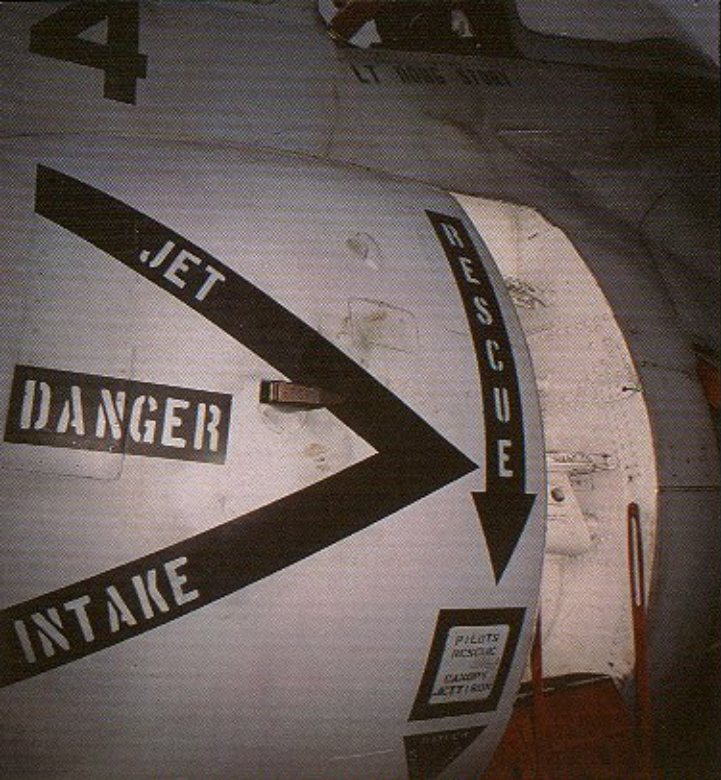
The object in the center of the danger markings on the port side air intake is the Angle of Attack (AOA) sensor.

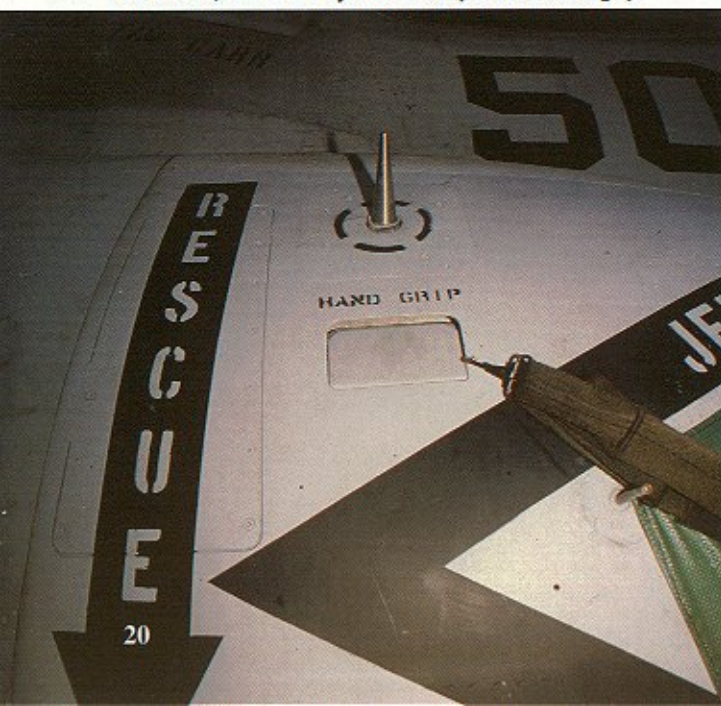
The temperature probe is located on the starboard engine air intake, immediately above the push-in hand grip.

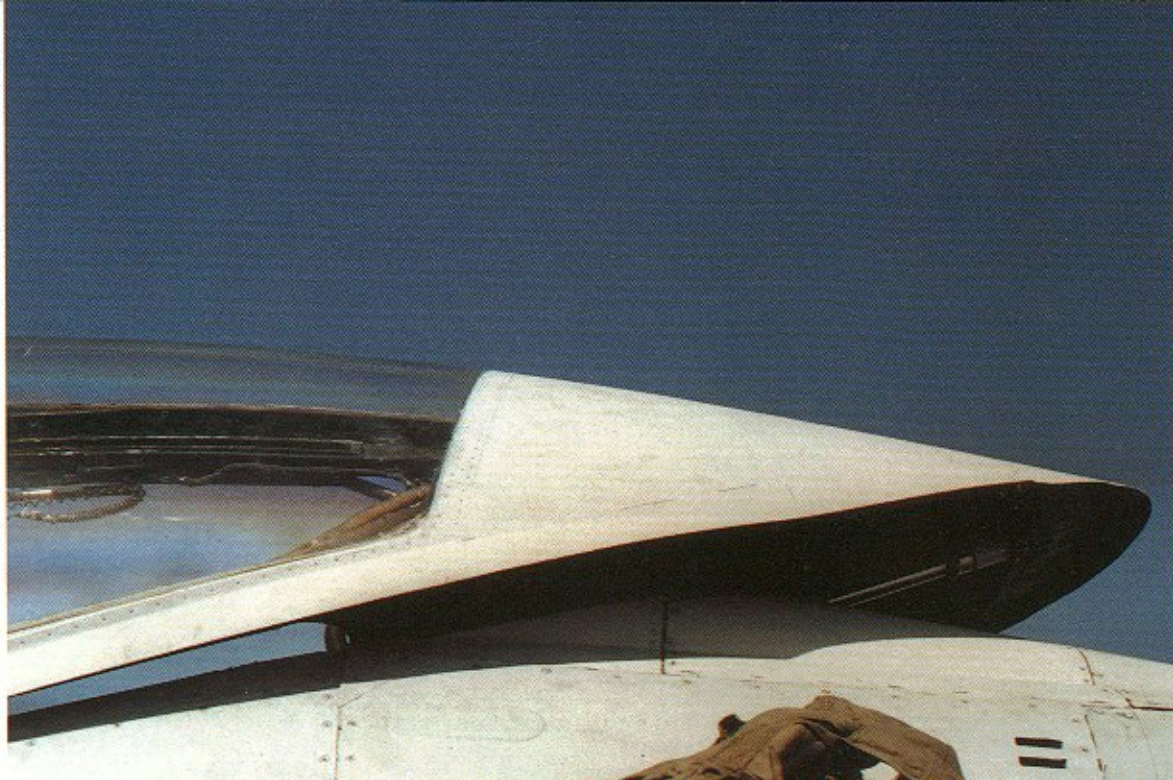
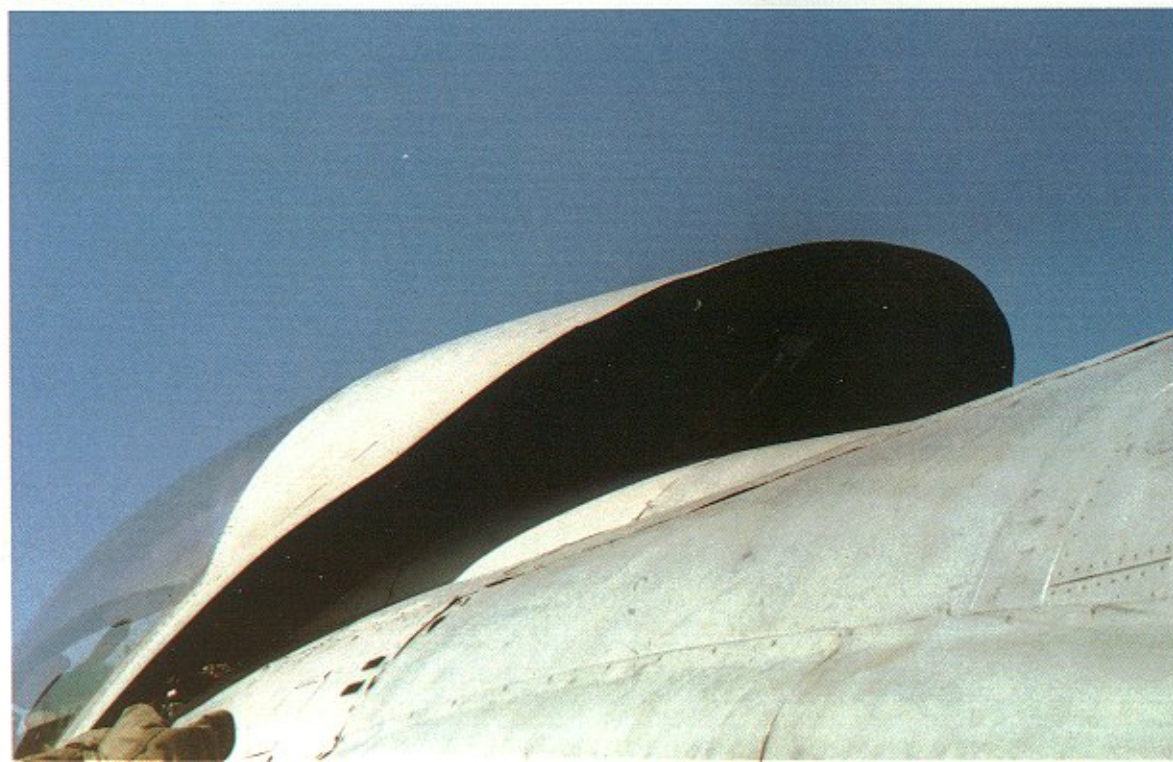
The canopy on the A-6A through A-6E slides to the rear controlled by the hydraulic piston visible at the rear of the open canopy.
